# TECHNICAL BULLETIN (M17)

## BI-XENON HEADLAMP FAULT CODES

FEBRUARY 2007

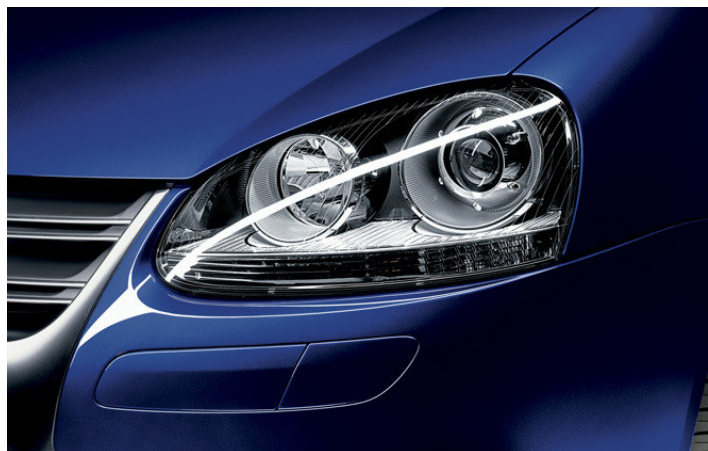
As part of the repair process the headlamp is removed and the vehicle is driven back and forth from panel to paint shop. When the vehicle is being reassembled and the headlamp re-connected it may not work. This is because each time the ignition is turned on the vehicle's computers check the wiring and circuitry for system faults. The disconnection of the headlamp will register as an interruption in the system therefore creating a fault code. A Volkswagen/Audi service department will need to clear the fault code before the headlamps will operate.

Remember, Bi-Xenon headlamps only will fault code.

Fault coding is possible to avoid by a repairer removing and replacing the headlamps without the ignition being turned on although in most repair scenarios this would be difficult.

Assessors may contact Industry Research for a cost estimate to clear the code.
