# TECHNICAL BULLETIN MISC 24

## SEATBELT CHECKLIST

APRIL 2010

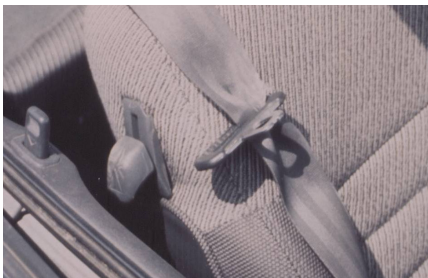
Examples of damaged webbing

The following checklist incorporates recommendations made by the study team. This checklist should be referenced when making assessments on extensively damaged vehicles. Note that under no circumstances are second hand seatbelts to be fitted.
